Where do Sea Ray 390's Leak? Let me count the ways starting from bow to stern:

How do I know where the leaks are? I did a 5 year hull up restoration of an 87 diesel 390EC.

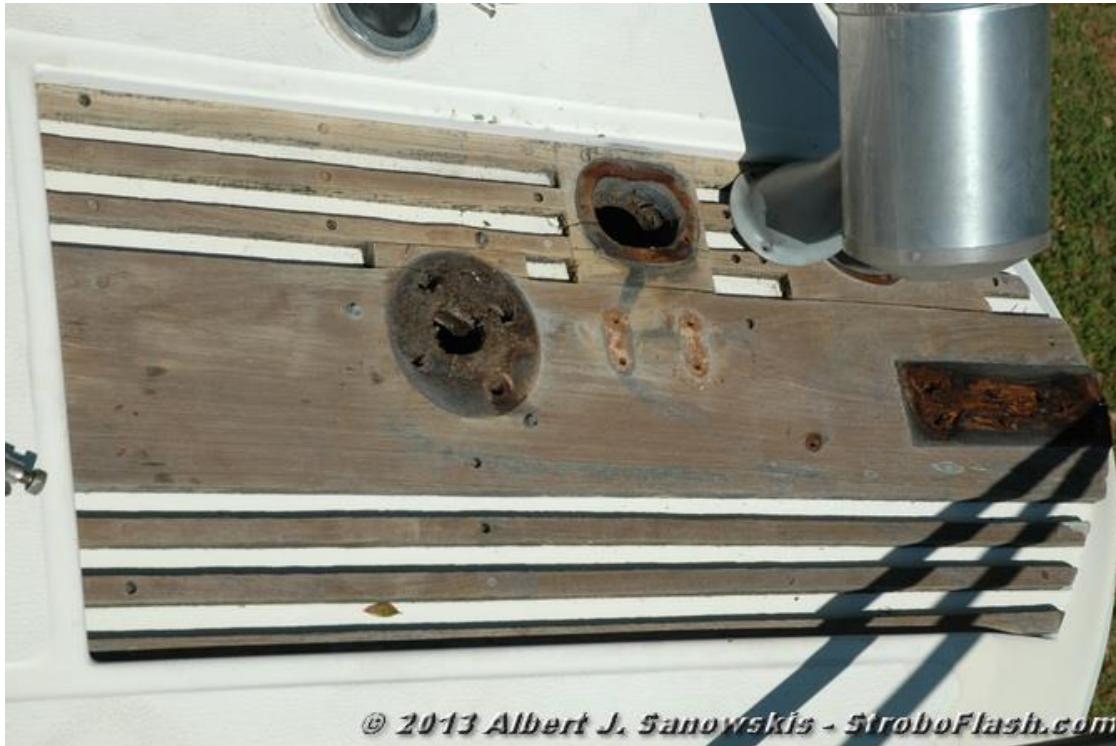
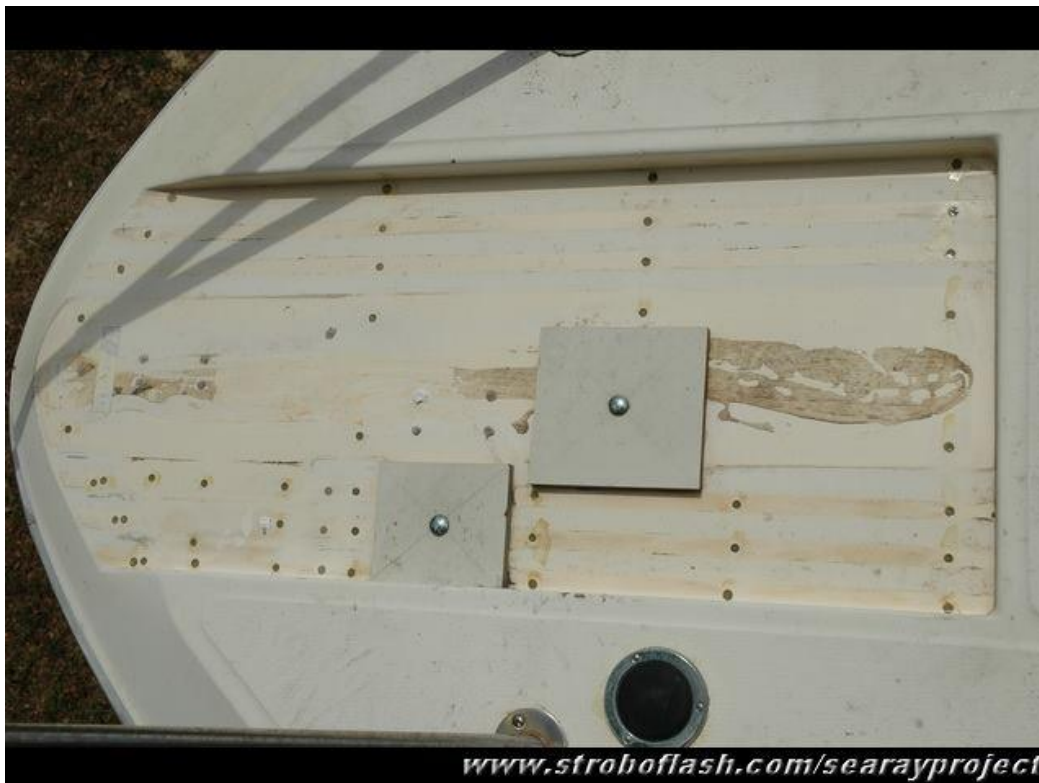
The drain in the locker is very small and clogs easily. Water comes in from the hole where the rope/chain goes out. Also all the screw holes that attach the teak trim above will leak rotting out the plywood deck core under the windlass. Water will eventually rot the bulkhead between the vberth and locker allowing water to run in to the salon bilge through the storage compartment below the bed. It may bypass the compartment. There is a glass covered wood structural beam under the floor below the shower sump that will rot when wet.

Figure 2 Guess where the water leaks?

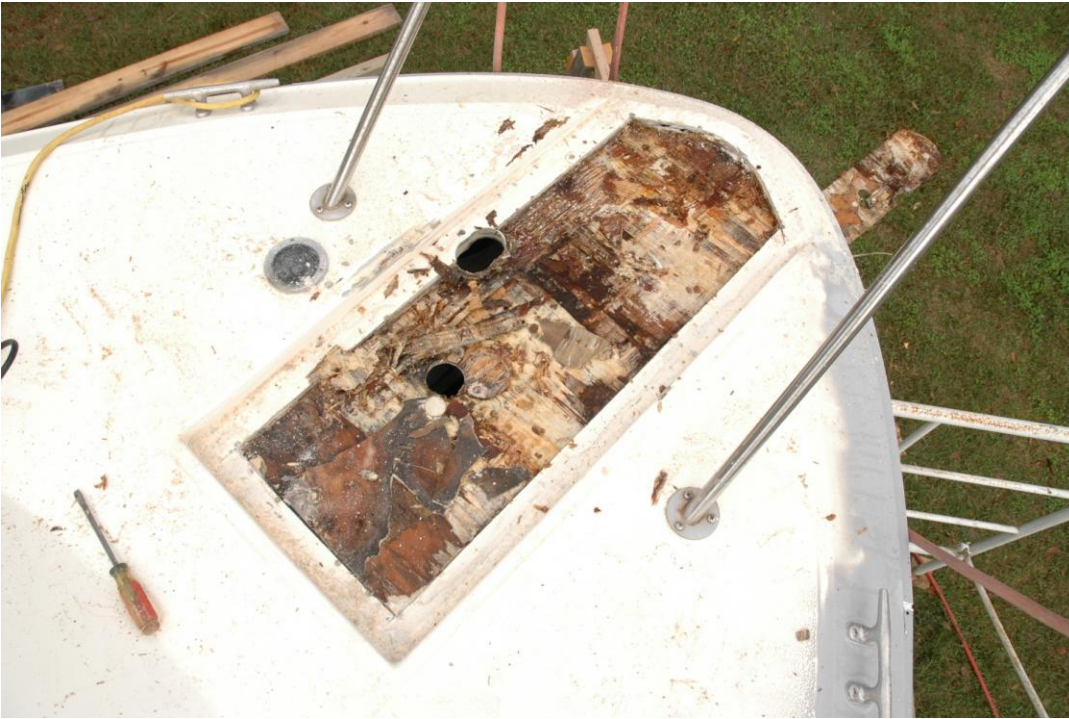
Figure 3 Totally rotted

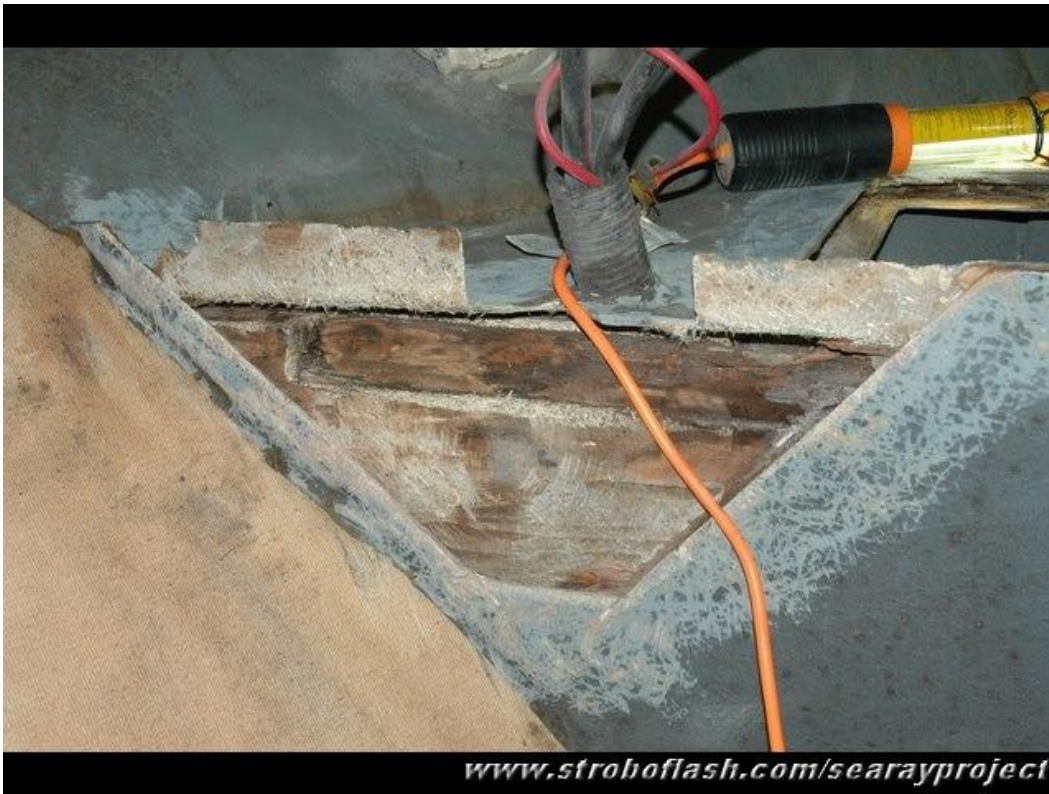
Figure 5 Bulhead rotted

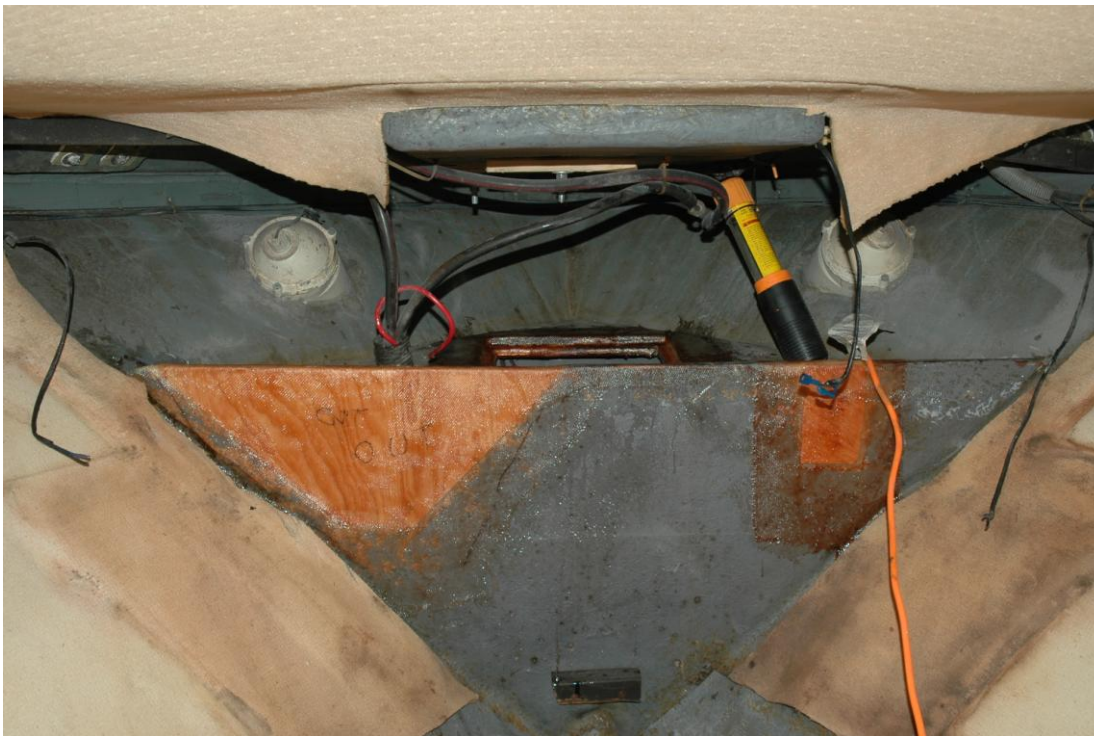
Figure 6 Water from above rotted out the bulkhead

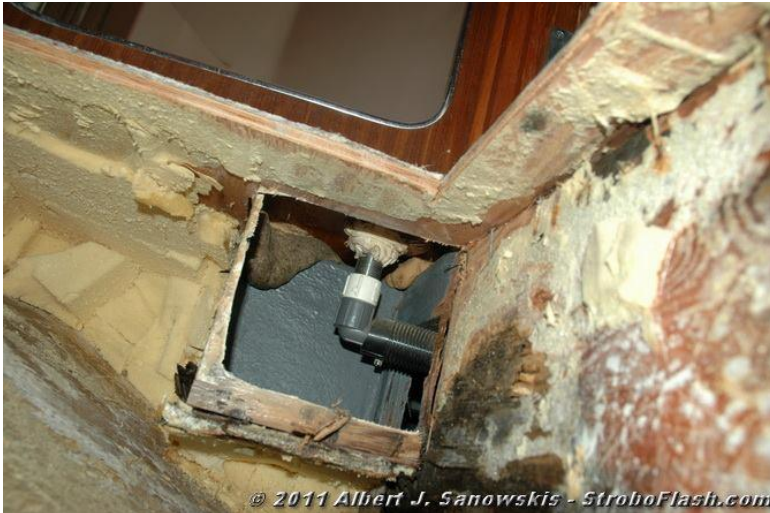
The shower drain is almost totally closed in and you may have to cut the floor in the head and then cut through a wall under the floor to get to it. It is poorly sealed with silicone and will eventually leak. You will probably not see the leak from the shower drain. It will leak in to the area behind the port stringer and eventually rot the stringer as it has no glass on the outboard side.

Figure 7 Shower Drain revealed

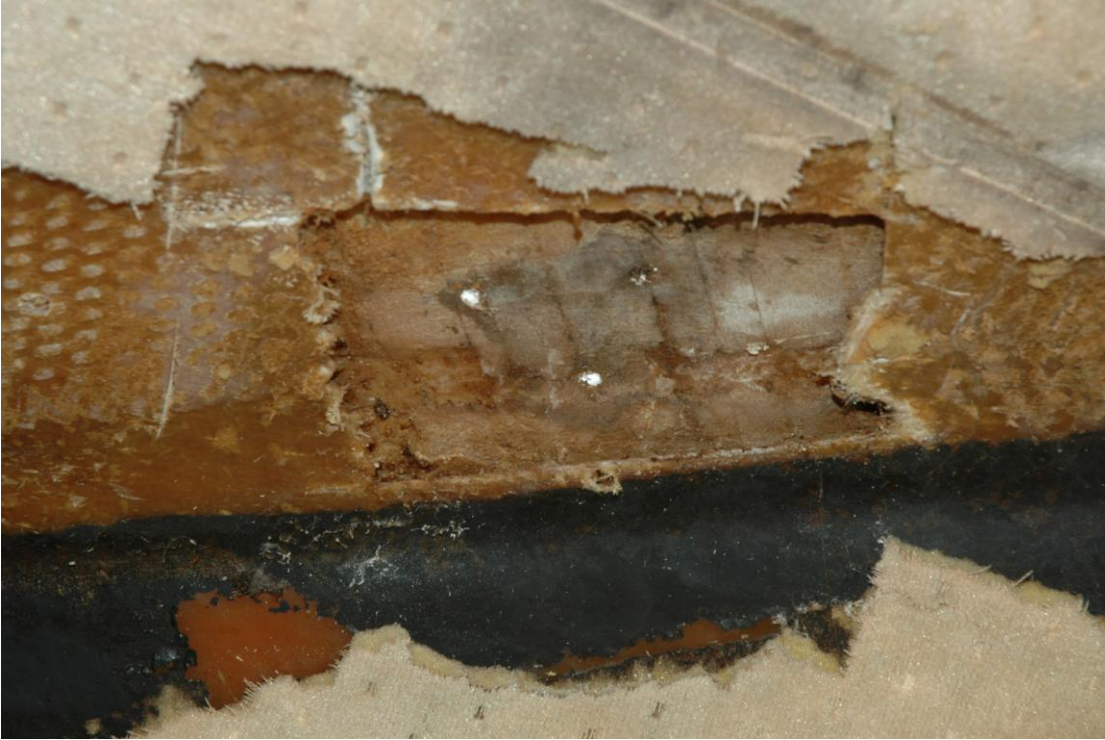
Everything was sealed with silicone and everything will leak. The stanction bases are no exception. When they leak the water goes in to the deck core and you have a big problem. Many of the base screws are behind cabinets and are very difficult to get to. If you can get to the nuts to remove the base then clean the area and caulk with 4200. Use three 1/8" spacers so you don't squeeze out all of the caulk. Tighten the screws after the caulk hardens. To fix a mushy core you have to remove the glass from below and fill with solid glass and epoxy.

Figure 9 Dig out rotted core from below and fill with glass and epoxy.

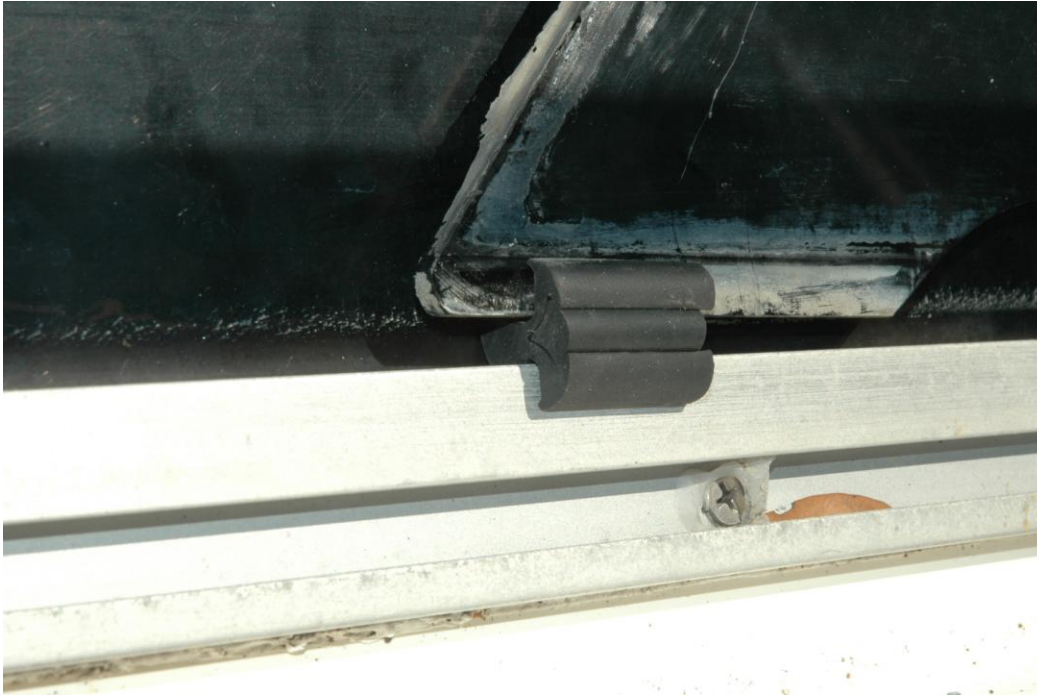
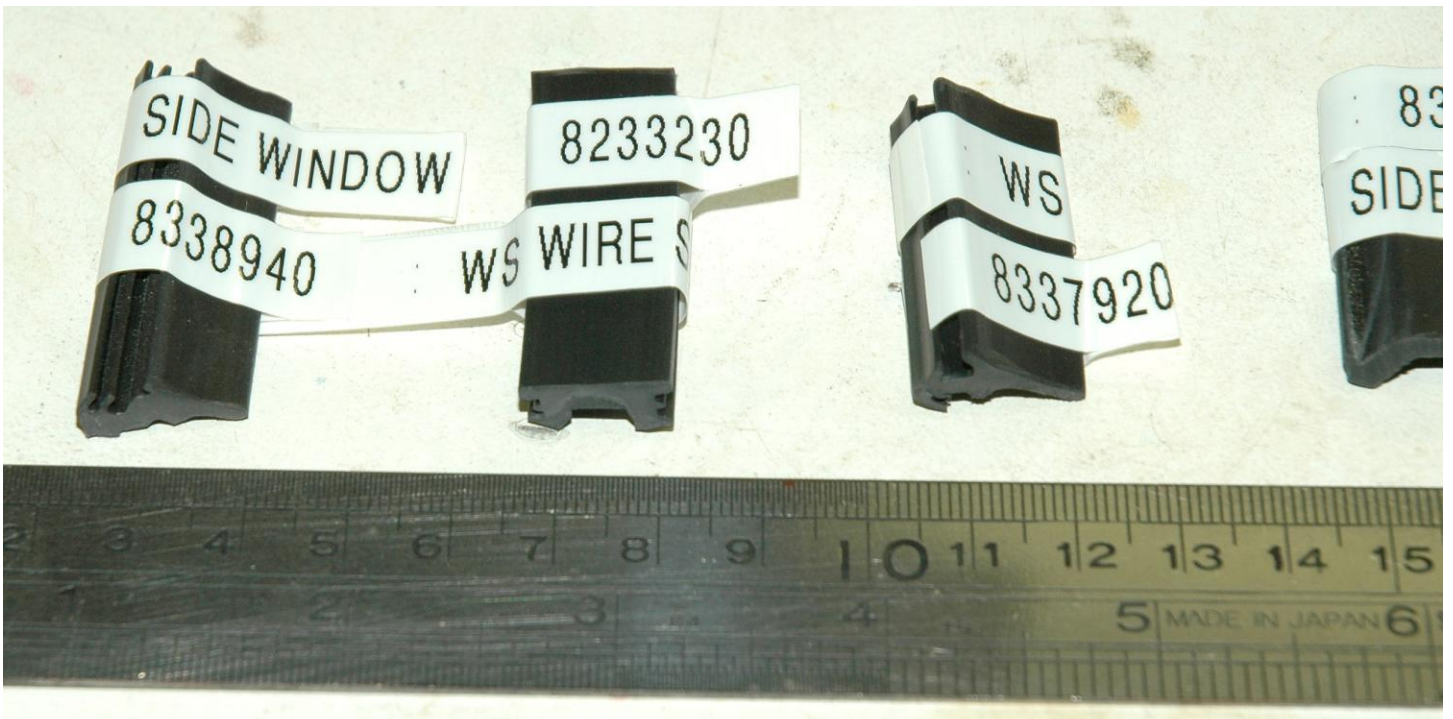
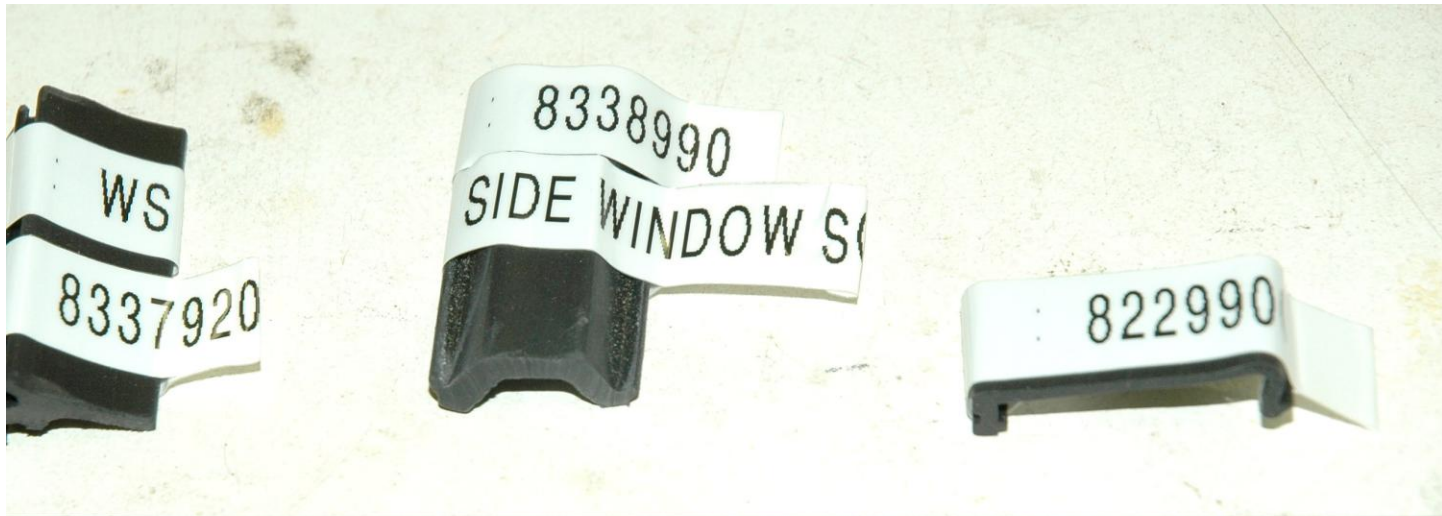
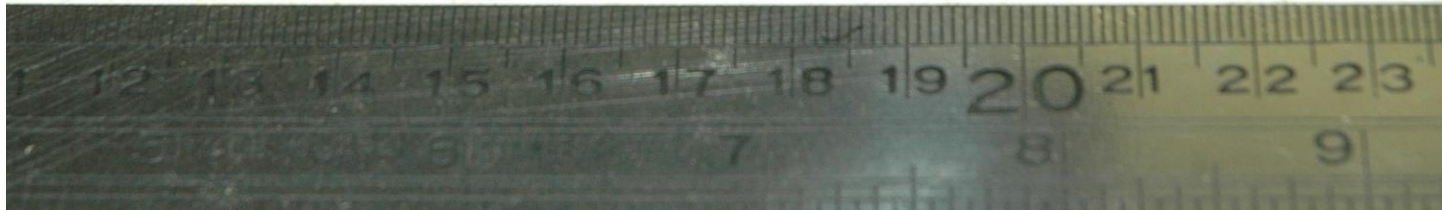
The bane of all Sea Ray owners. They leak because the acrylic window expands and contracts about ten times more than the aluminum frame thus breaking the double sided foam seals. I rebuilt the windows and used a high tech industrial rubber seal. It was very difficult and required great skill to install. I cannot recommend the system for the average owner. So I am now recommending black butyl tape that the window glazers use. (dkhardware.com) Two 1/8" strips to make a 1/4" thickness should do it and you will also have to get new rubber seals and trim from Sea Ray or Taylor Made. You may also have to pull the aluminum frames, clean off all the silicone rubber and reseal with 4200. Be prepared to inject rot stop epoxy in to some of the screw holes as the wood below may be rotted.

Figure 12 TrimLok.com industrial rubber seals. Not recommended for the average owner to install. New acrylic has to be cut and rubber has to be cut VERY accurately at extreme angle corners. Corners must be caulked prior to installing acrylic. Then I still had leaks after the rubber shrank after a couple of years.

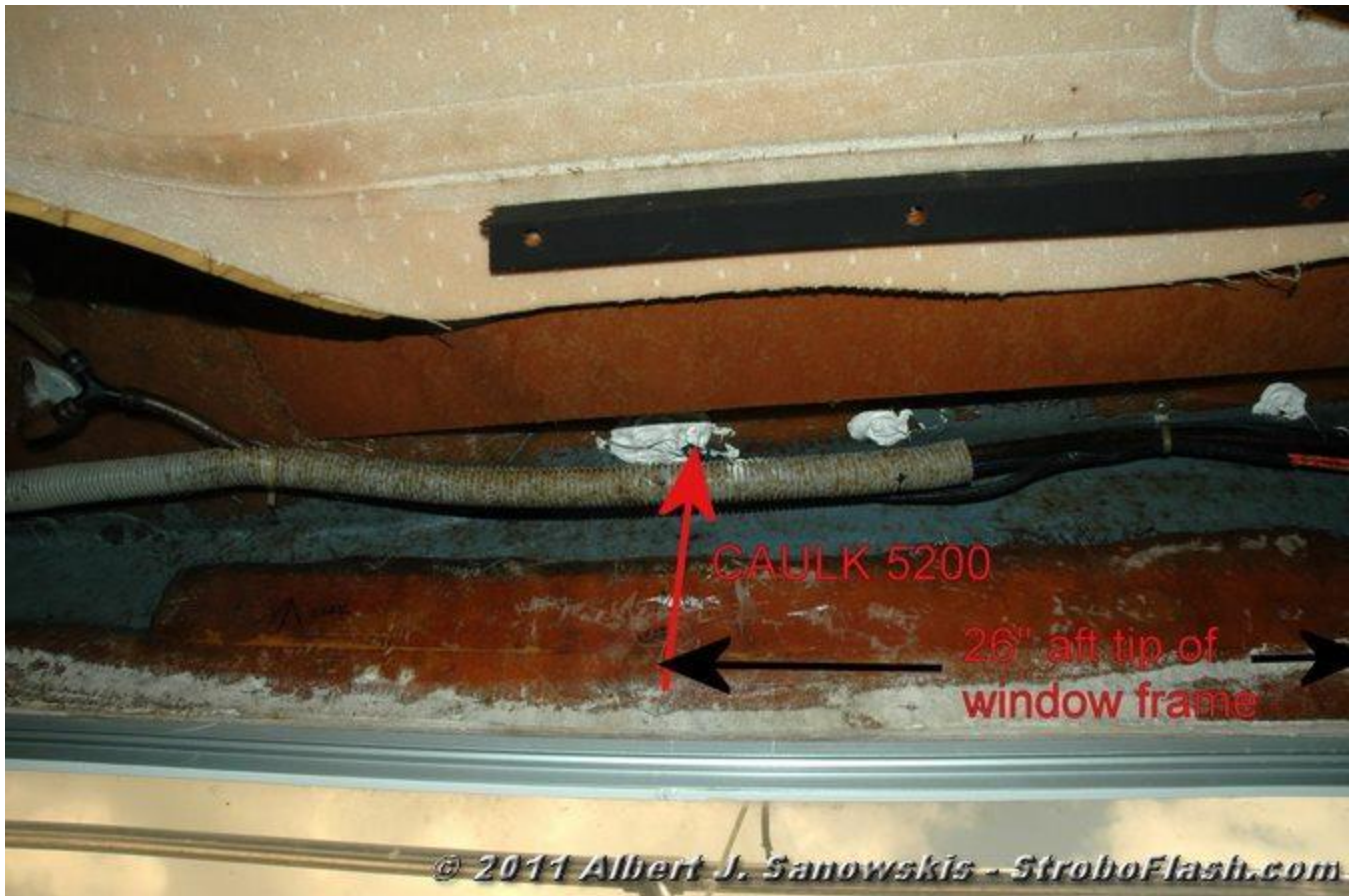
Figure 17 This is right above the stove. You have to pull some woodwork down to get to it but it leaks when water gets behind the windshield. See above photo.

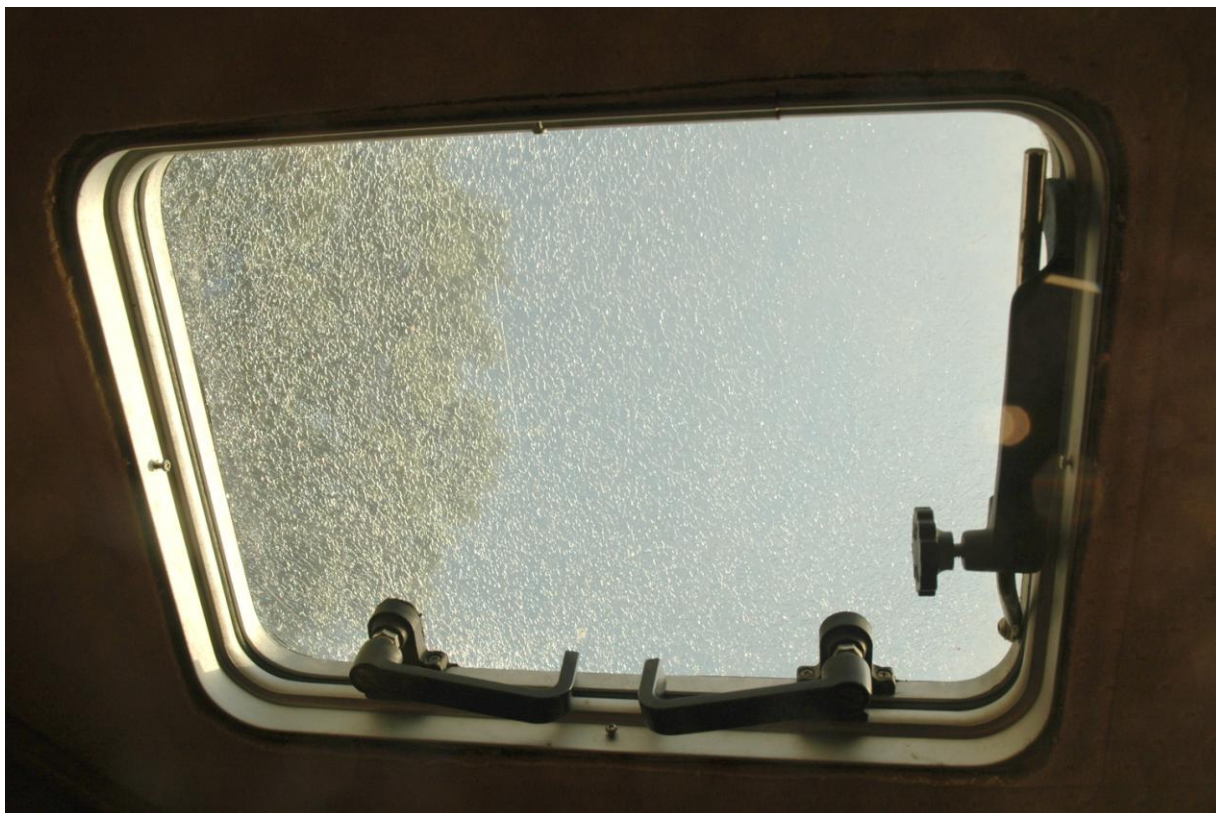
Figure 18 Might want to pull the hatch frames and seal them with 4200. They also leak. The crazing in the acrylic seems to be only cosmetic and only on the outside surface. Just looks bad.

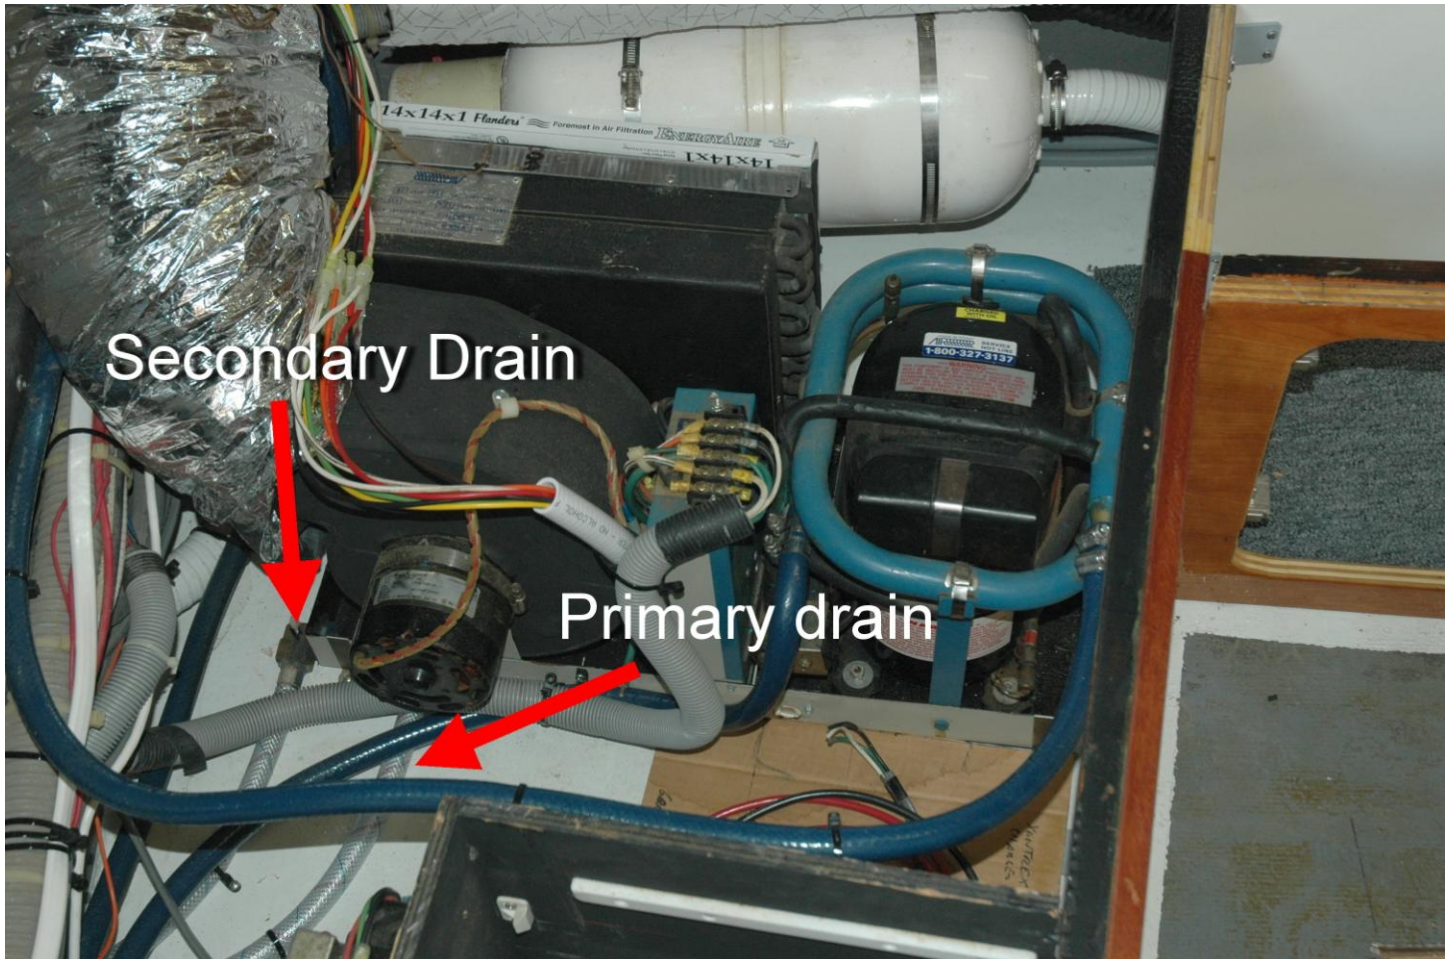
All air conditioners remove water from the air and have a primary and secondary condensate drain. The primary comes off the pan directly under the evaporator coils. This pan will corrode and leak thus dumping the condensate in to the larger pan under the entire unit. The secondary drain on the 390 is left open so if the primary pan fails all the water leaks in to the center bilge. I had to pull both units and build new primary pans out of stainless. The primary drain on the A/C under the bunk goes in to the shower sump. The secondary goes in to the bilge. The primary on the salon A/C under the couch goes through the engine room bulkhead and in to the forward sump. The secondary drains on to the floor and in to the center bilge. I added a new drain line to the secondary that also goes in to the engine room sump.

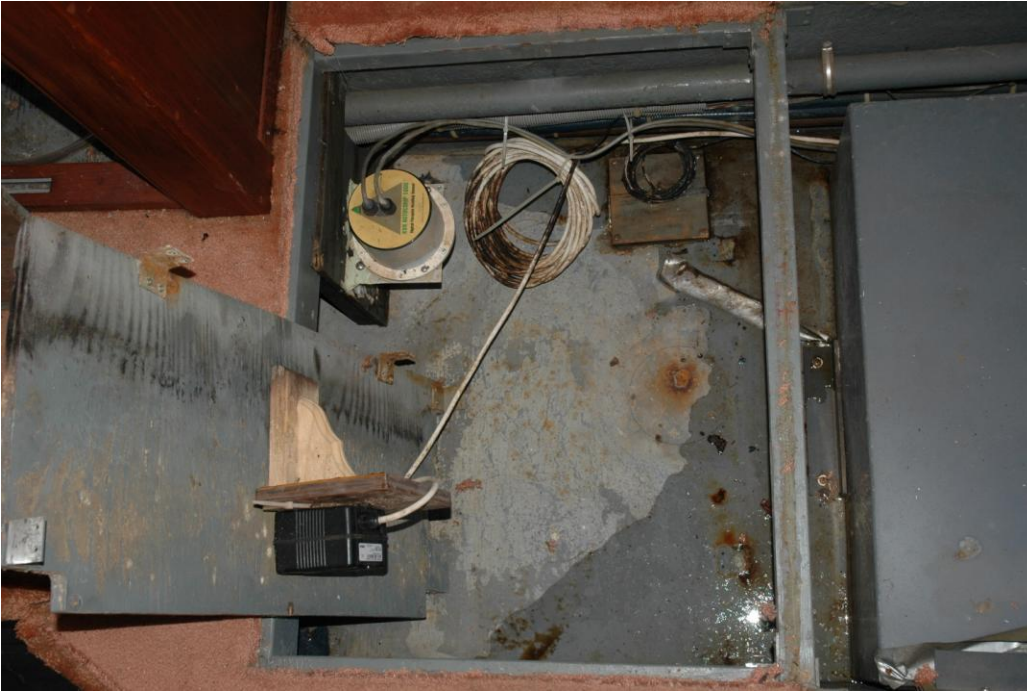
Figure 19 This is what I found under the center hatch when I acquired the boat.

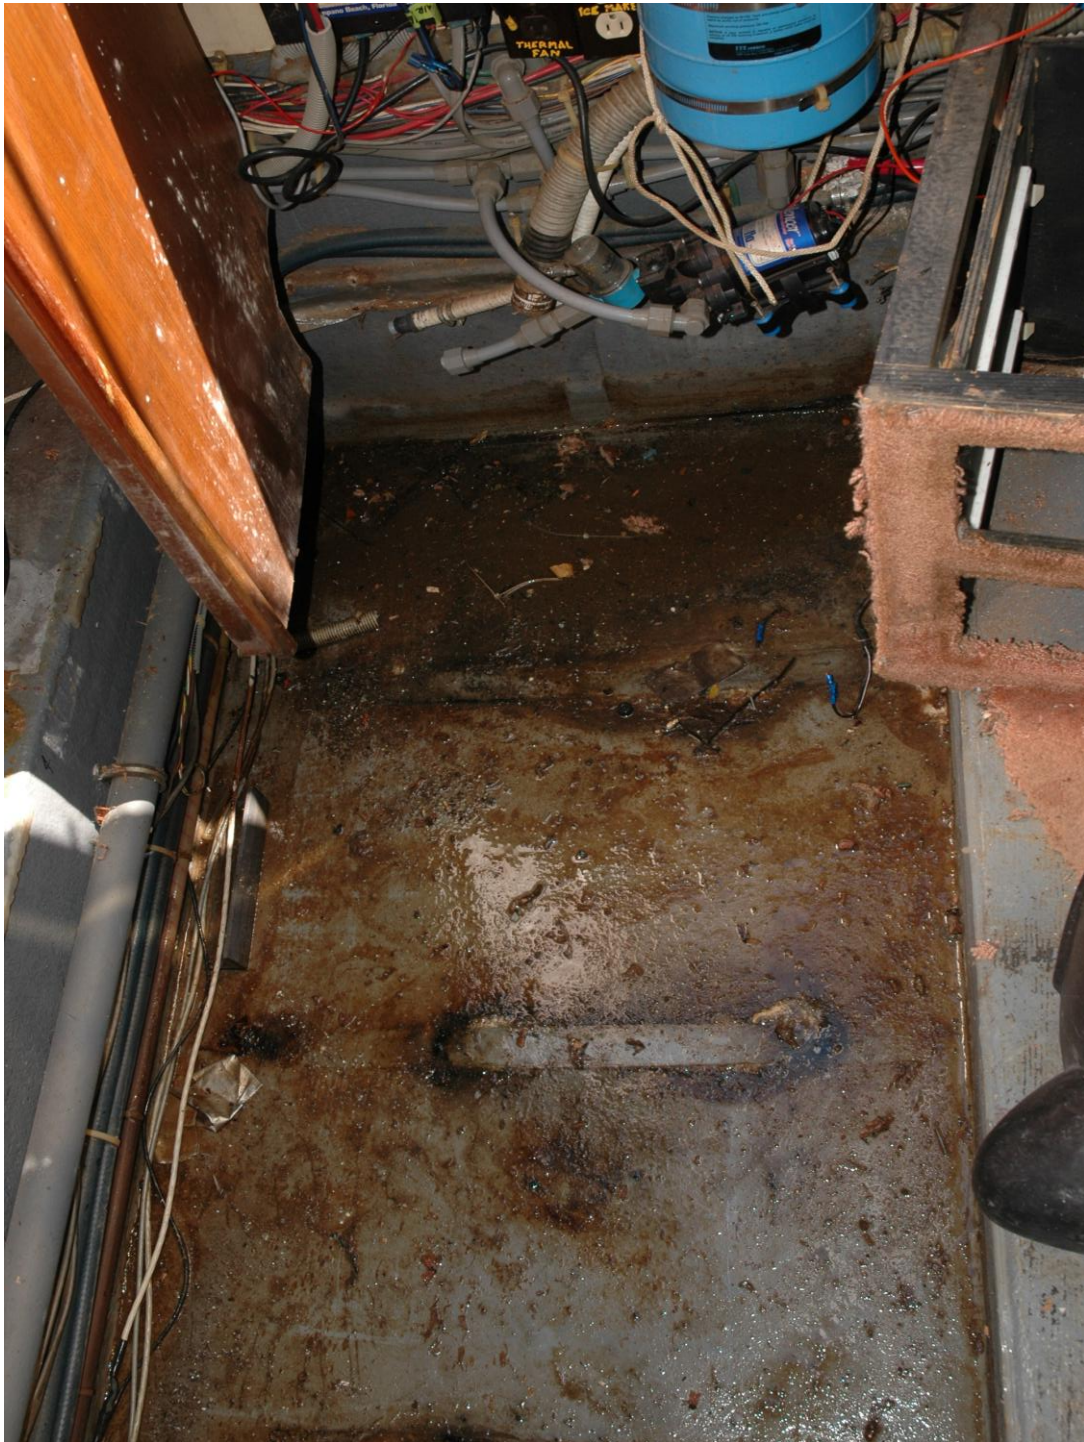
Figure 20 This is the wet mess I found under the water tank. The tank had a zillion holes in it from crevice corrosion. Google it.

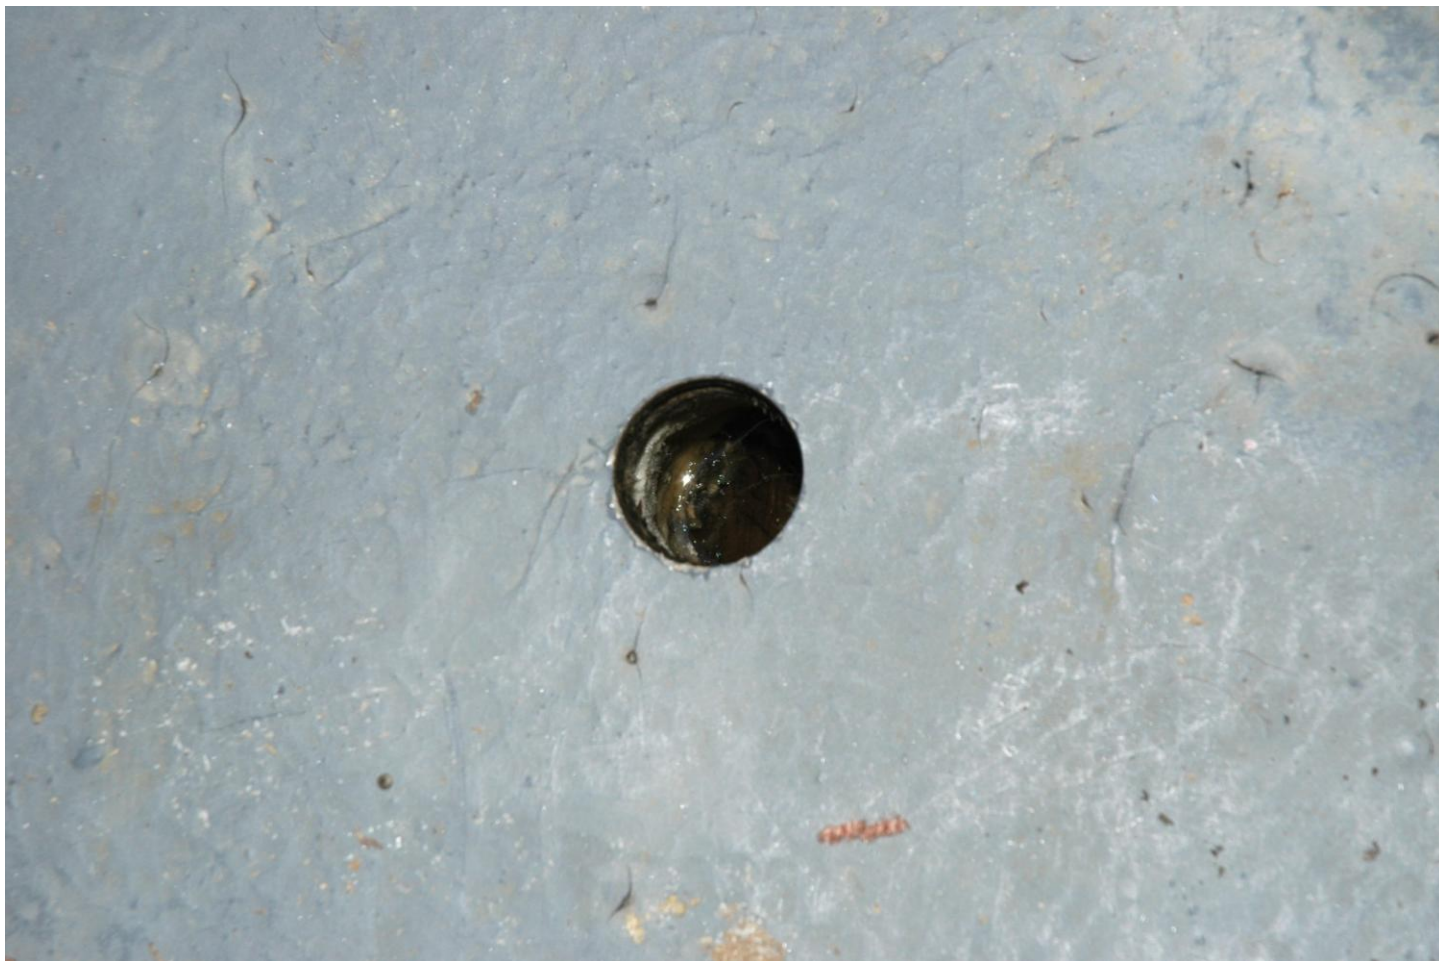
Figure 21 I drilled a hole in the floor and found water under the floor that the tanks sits on. Bad news. That means the stringers are wet.

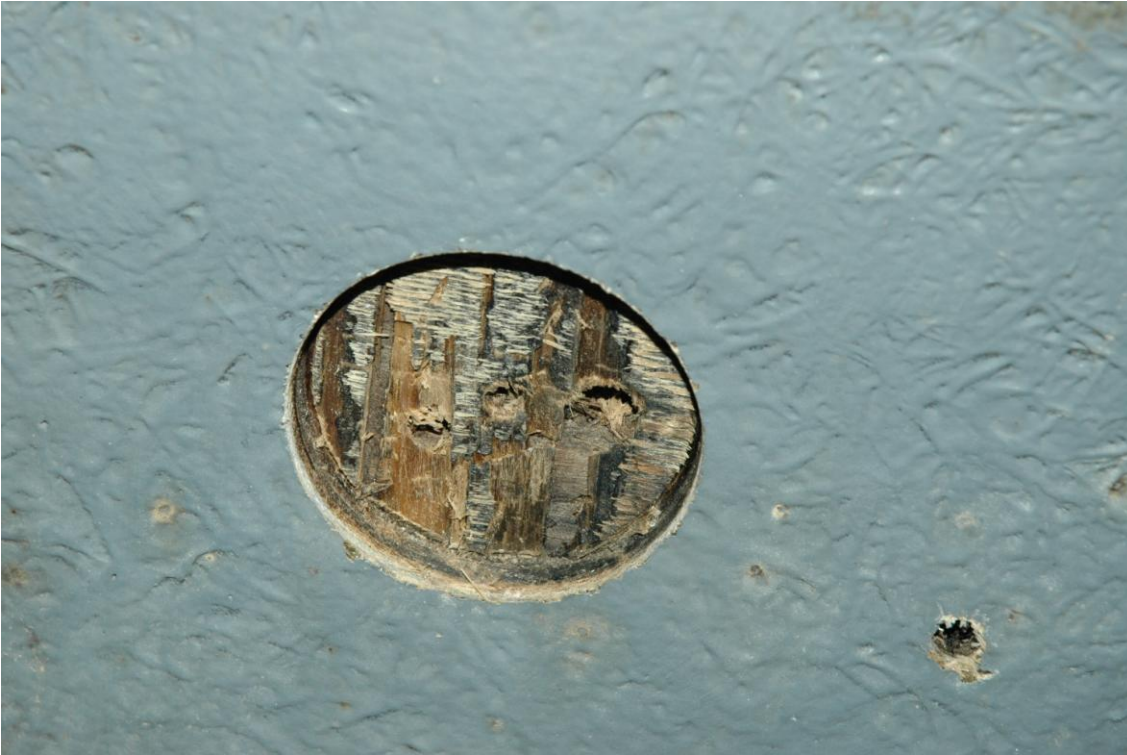
Figure 23 I drilled some holes in the stringers and found them to be wet and rotted.

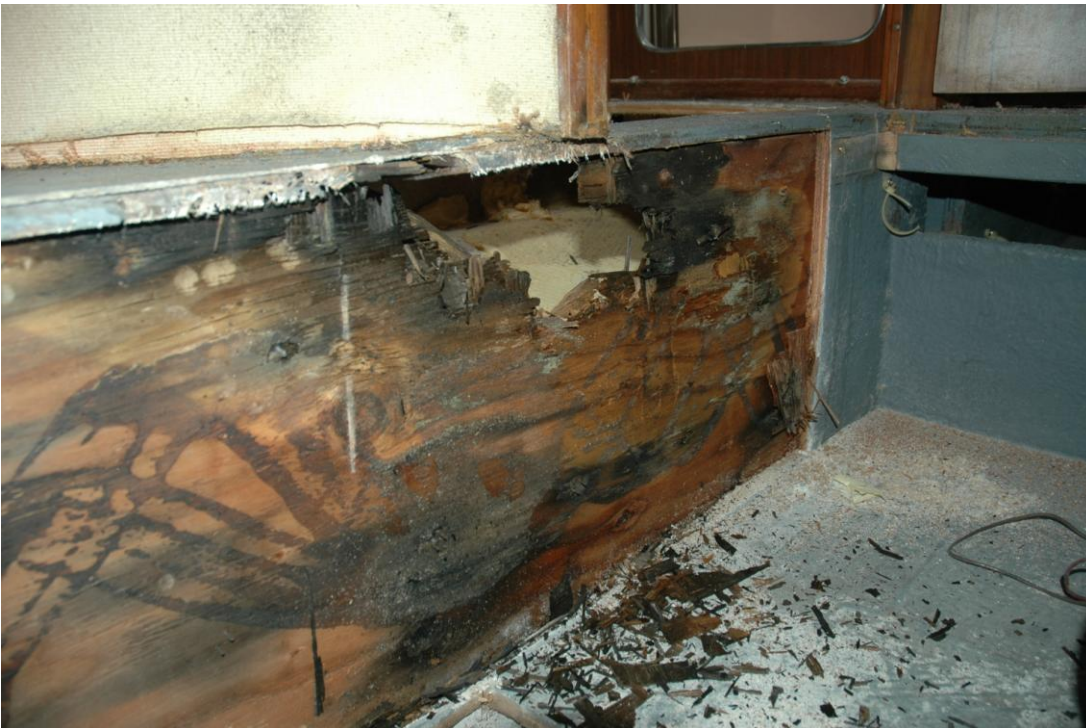
Figure 24 Rotted stringer from leaking shower or side windows.

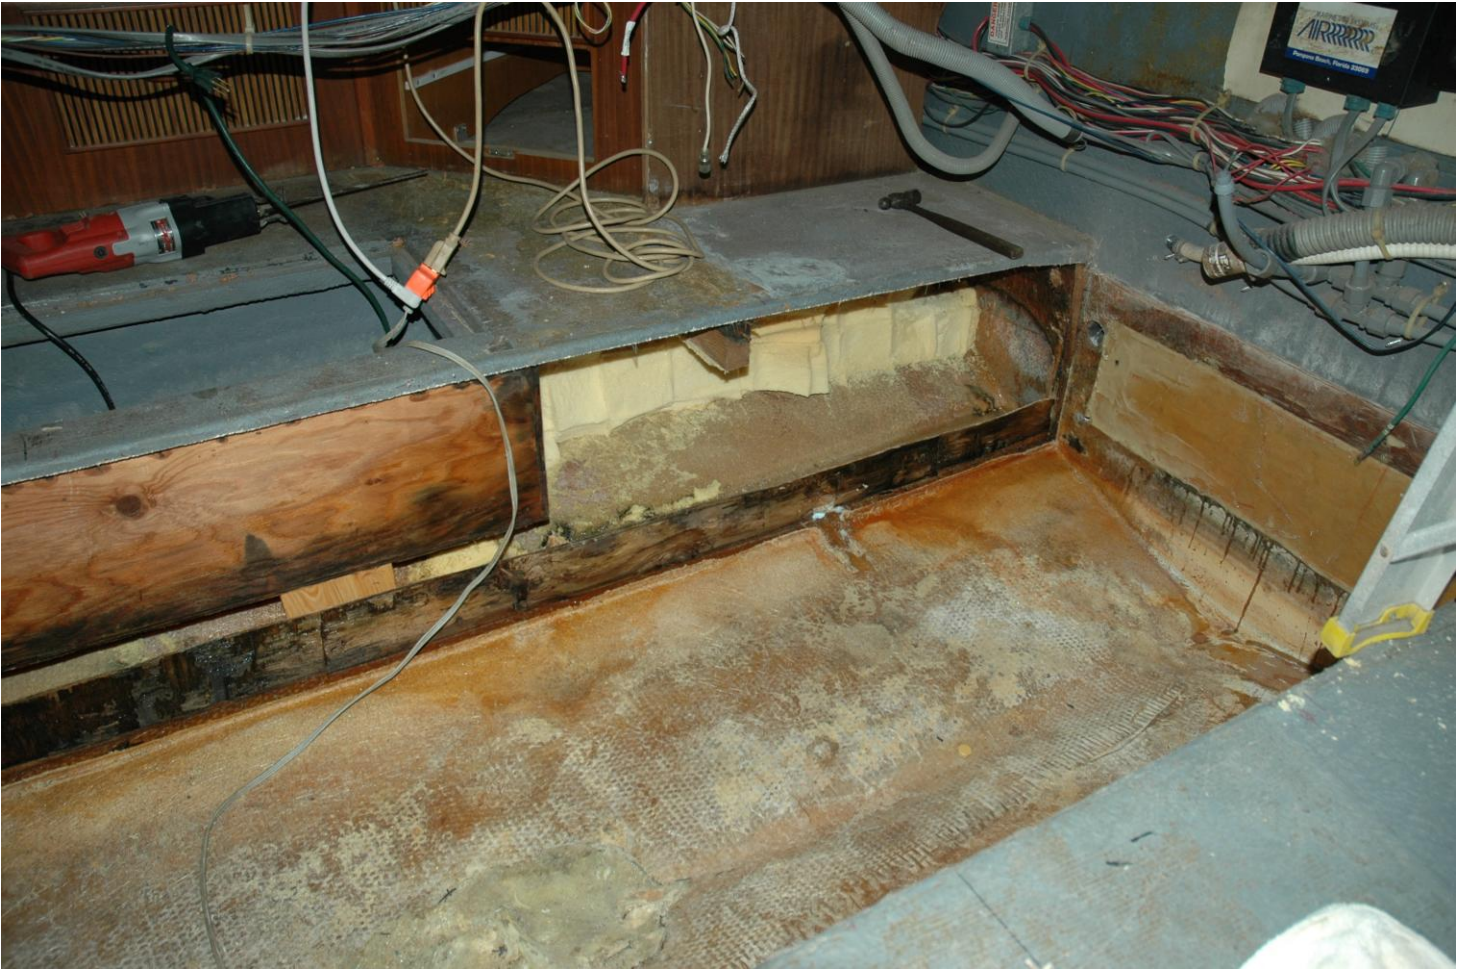
Figure 25 I cut out the stringers. They came out in handfulls of rotten wood
