Autopsy A Westerbeke / Universal Marine Heat Exchanger

Westerbeke 3" Heat Exchanger

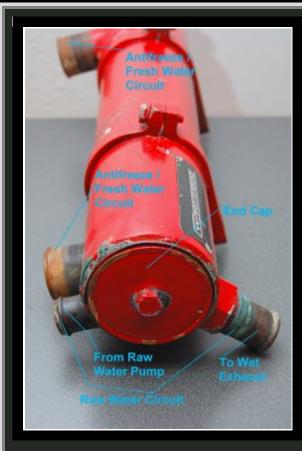
This is a typical 3" raw water heat exchanger as found on many Westerbeke an Universal diesel engines.

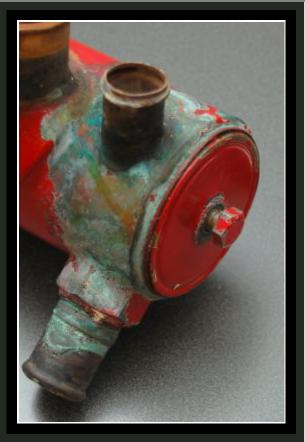
Close Up of End Cap

The end caps on these HX's are prone to leaking if the gaskets are not replaced on a fairly regular basis. These end caps provide access to the heat exchangers copper tubes.

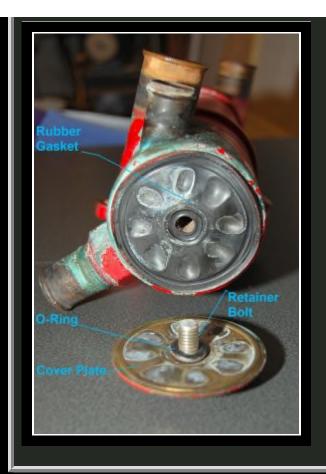
How A HX Works

If you follow the arrows you can see that this HX is broken into quarters and is a four pass HX. Raw water enters & then

flows to the opposite end, returns to the inlet end, turns and heads back to the opposite end and finally turns back towards the inlet end and finally gets ejected into the wet exhaust system.

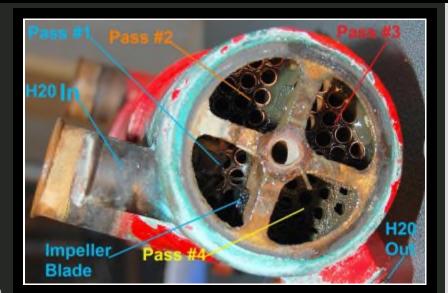
If you click on the picture to blow it up

you'll notice a chunk of an impeller blade that took up residence in the heat exchanger.

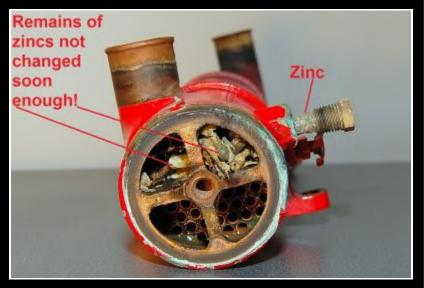
The Zinc End

This is about as good an example I can come up with as to why you need to change your HX zinc regularly. Each engine will be different in regards to zinc erosion so test it at three, four, six weeks etc. to see which works best for you.

This is WHY these heat exchangers have end caps...

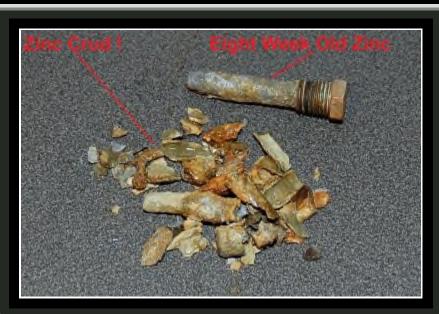
Zinc Pieces

All this crap came out of the zinc end of the HX and was impeding raw water flow. This type of crud can lead to an engine overheat. Of course this overheat will only happen when running a dangerous

inlet in 8 foot following seas at 2:00 a.m., because Murphy is always waiting. Don't let Murphy get you, head him off at the pass and change your HX zincs regularly. The zinc pictured was just eight weeks old and probably should have been replaced at about six weeks as it was already shedding.

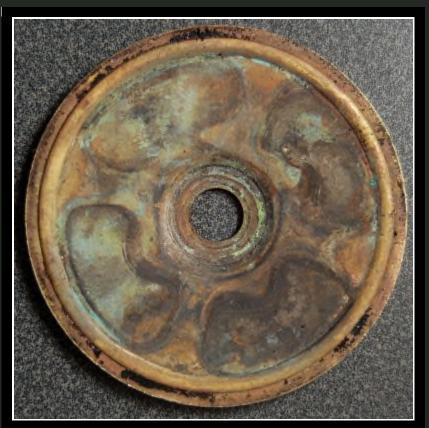
HX End Cap Before

Most often the end caps are reusable but they do need to get cleaned up or the gaskets may leak.

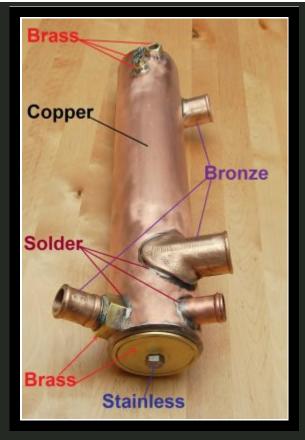
Dissimilar Metals

So why do I need a zinc again.....????

That's right these heat exchangers can have as many as FIVE different metals. Can you say galvanic corrosion stew...! The

zinc is there with good reason..

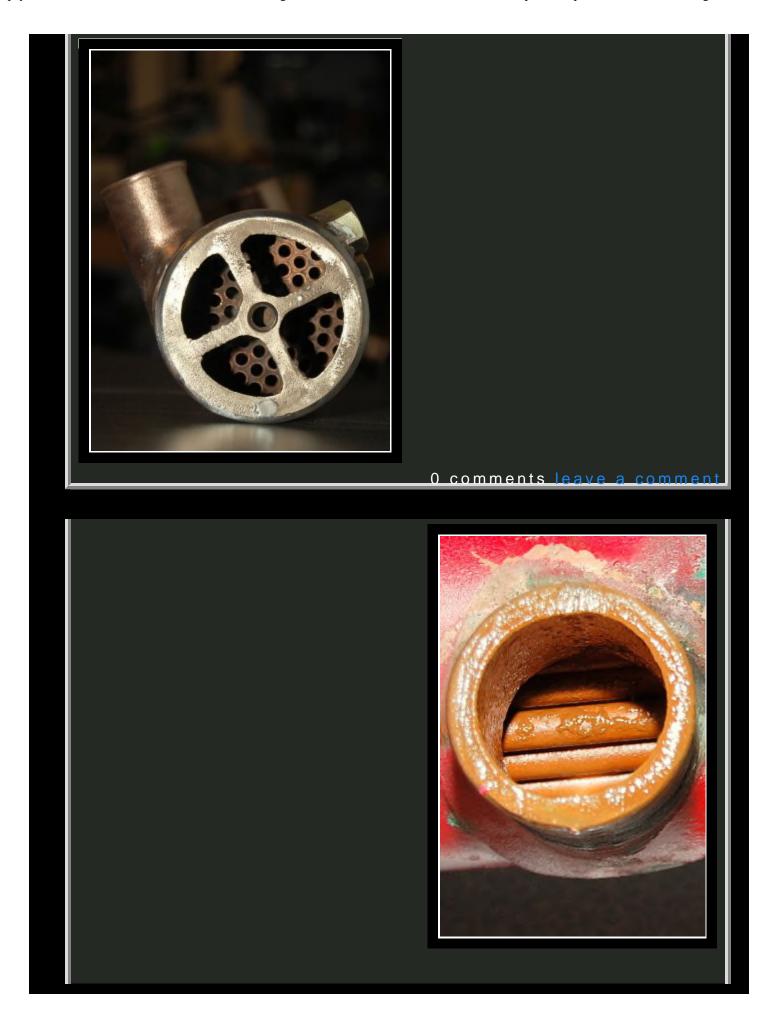
All Clean & Boiled Out

This is what the tubes look like after being "boiled out"...
