Where do Sea Ray 390's Leak? Let me count the ways starting from bow to stern:

How do I know where the leaks are? I did a 5 year hull up restoration of an 87 diesel 390EC.

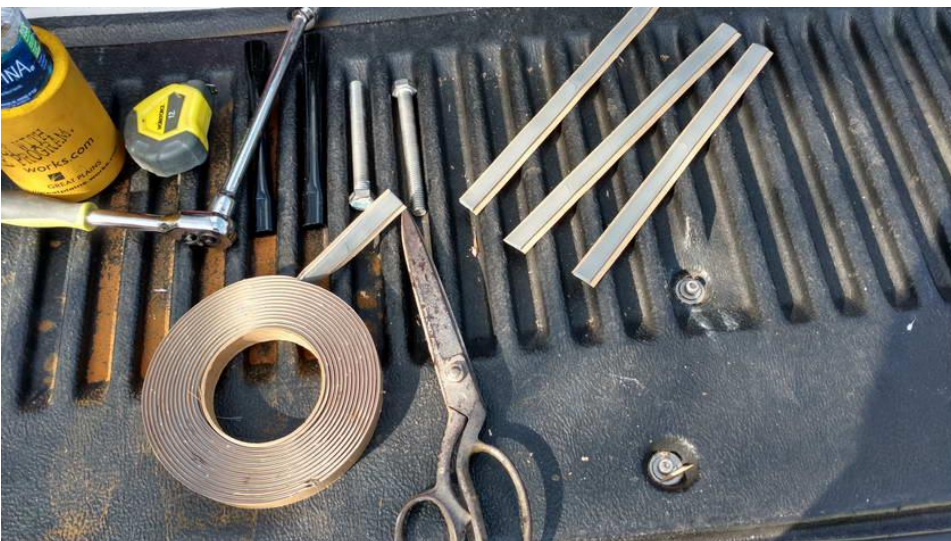
Figure 1 Butyl Rubber Caulk Strips

For windows and port lights use butyl rubber strips like used in window glazing. It remains flexible and will not dry out. It does not harden and is easily removed and replaced.

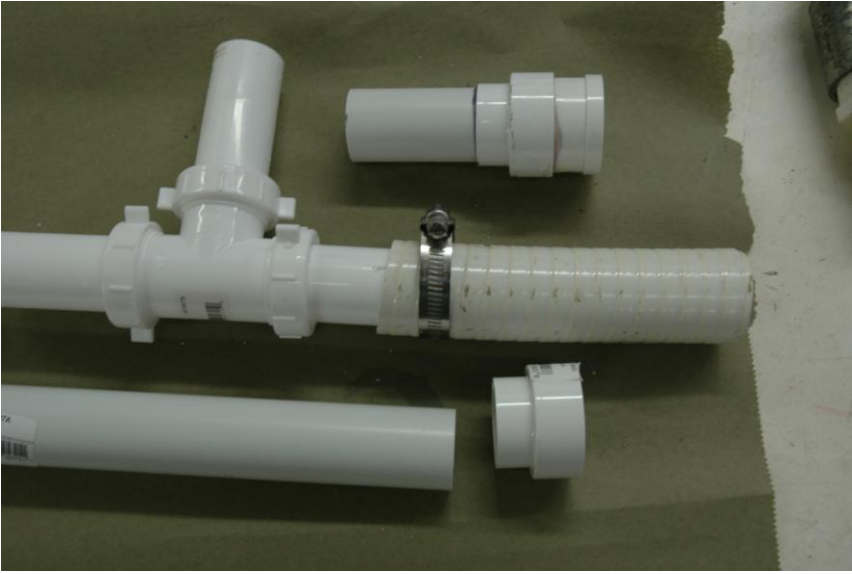
Check all your sink drains. If they leak water will find its way under the water tank.

Hardware store polyethylene or PVC drain pipe is a perfect fit inside 1.5" marine quality flexible lines

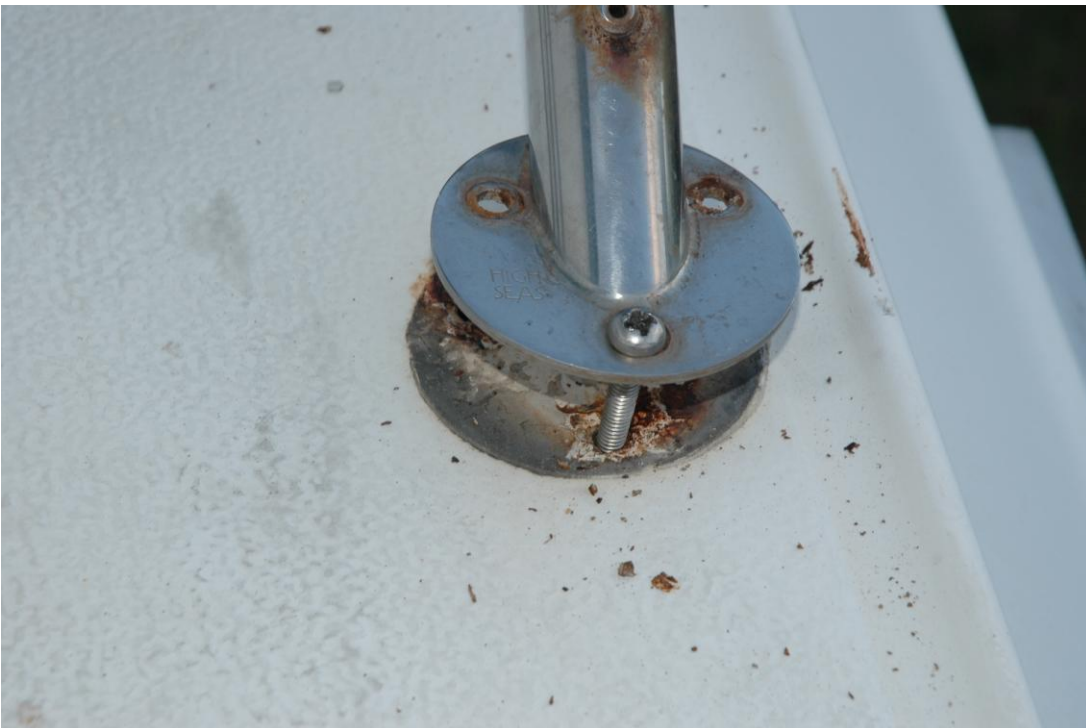
Figure 10 Stanctions have backing plates and nuts and washers below.

Everything was sealed with silicone and everything will leak. The stanction bases are no exception. When they leak the water goes in to the deck core and you have a big problem. Many of the base screws are behind cabinets and are very difficult to get to. If you can get to the nuts to remove the base then clean the area and caulk with 4200. Use three 1/8" spacers so you don't squeeze out all of the caulk. Tighten the screws after the caulk hardens. To fix a mushy core you have to remove the glass from below and fill with solid glass and epoxy.

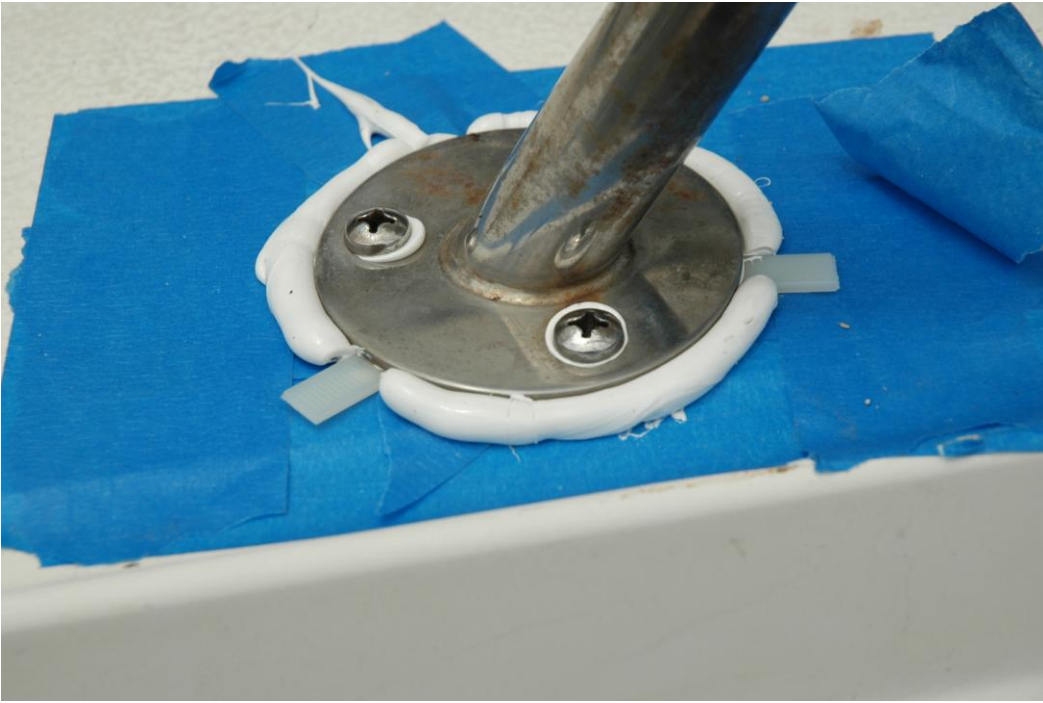
Figure 11 Let harden and trim excess. Pull the spacers. (they are only in 1/4")

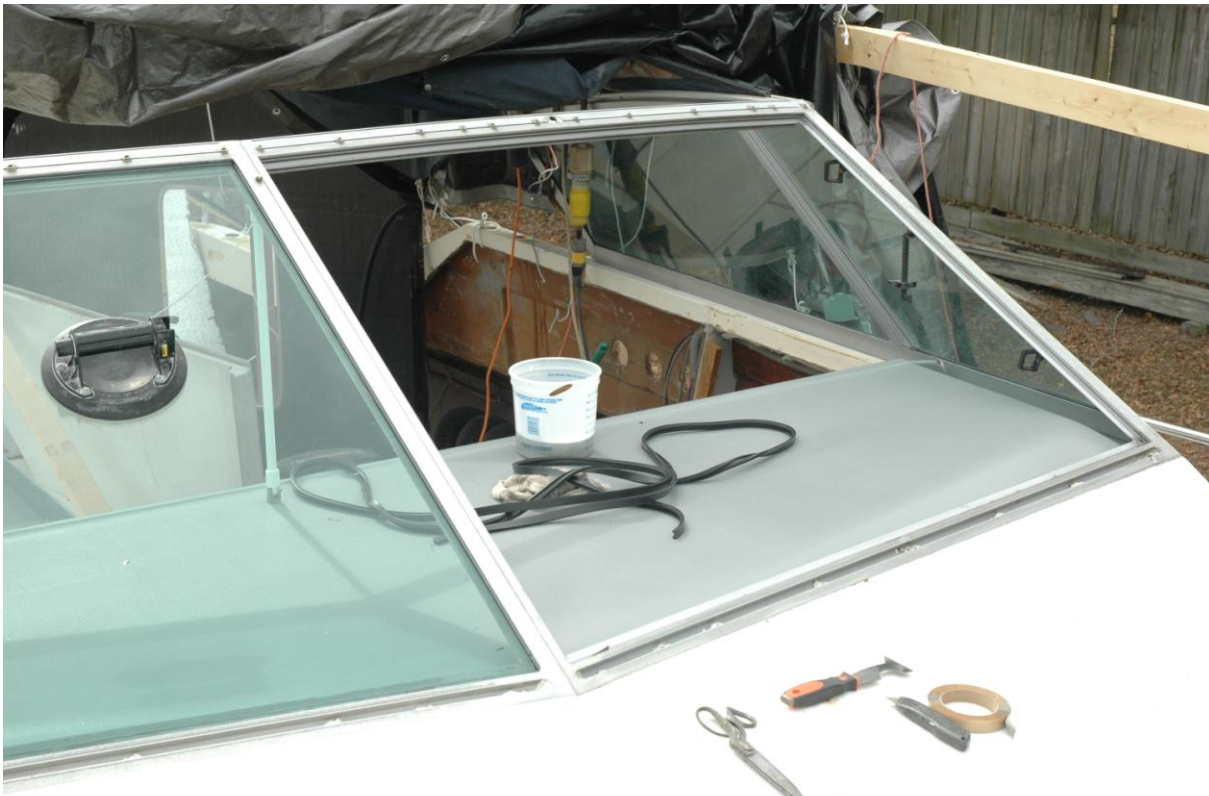
Figure 13 With a few tools it is fairly easy to R&R glass.

Once again the windshield frame is caulked in with silicone rubber and will leak. It is way too difficult to remove the frame however you can dig out as much caulk around the frame and then caulk with 4000UV. Also the screw heads under the trim strips need to be cleaned and sealed. After 25 years your windshield glass may have broken loose from the glazing sealant. The glass should be removed, frame and glass cleaned and new butyl rubber seal strips installed. This is not a job for the faint of heart but it can be done by an owner. You need a windshield seal breaker tool from an auto paint store, some suction cups from Harbor Freight and some glass stands made of 2x4s to hold the glass after removal. Butyl rubber glazing from dkhardware.com. If you can get a local glass company to do it you are better off. I did it myself but a helper is a real good idea.

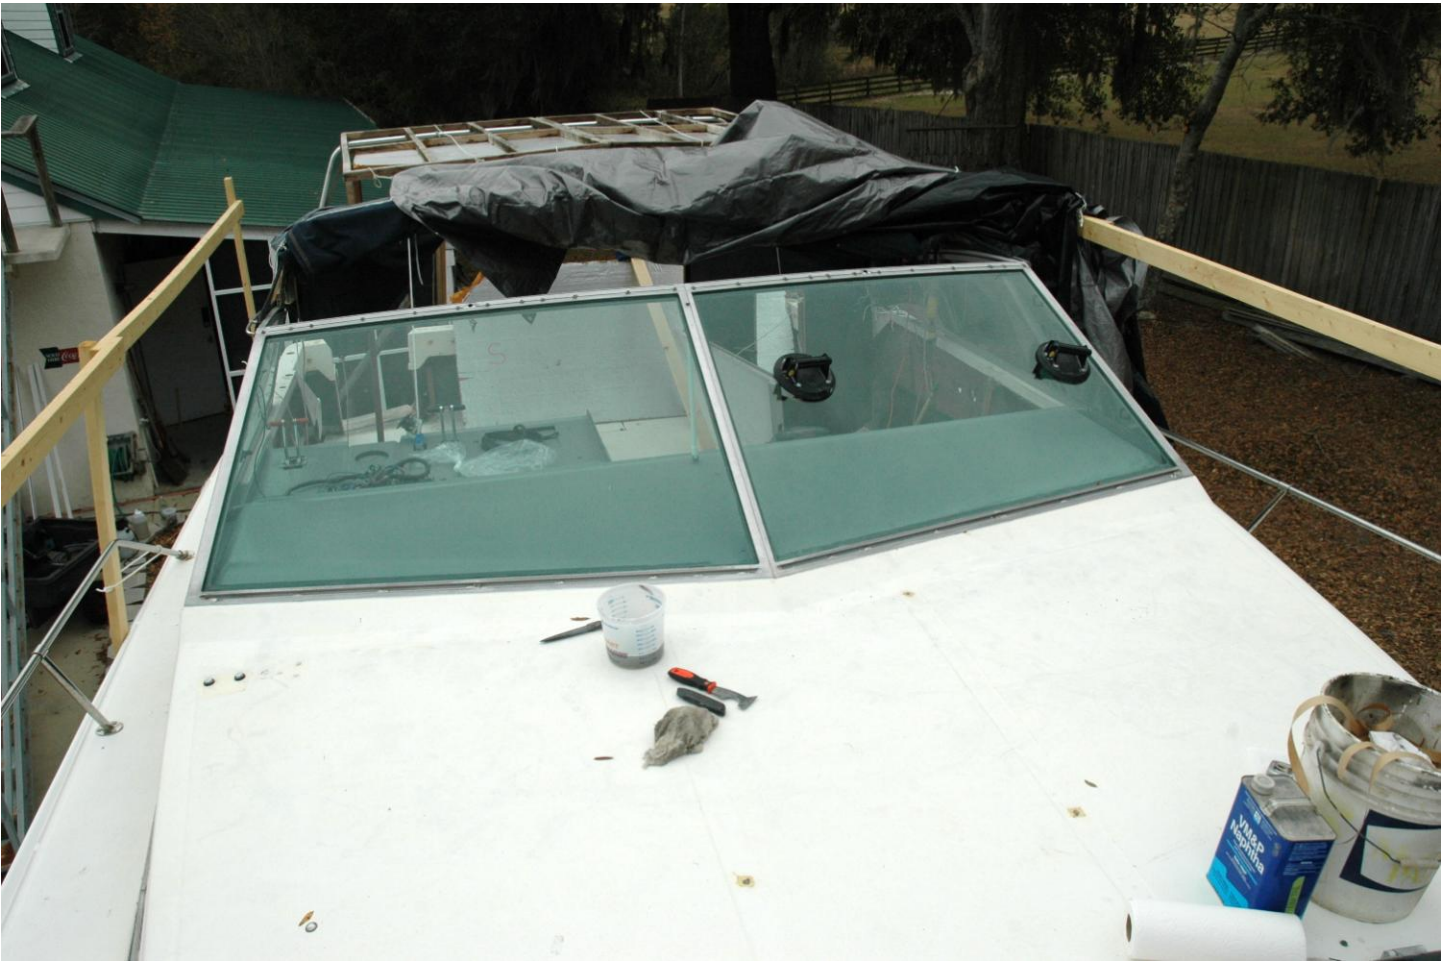
Figure 14 Clean glass and suction cups are the only way to handle glass. Never pull sideways on the suction cups! NEVER NEVER FORCE GLASS TO MOVE. IF IT IS STUCK FIND OUT WHY!!!!

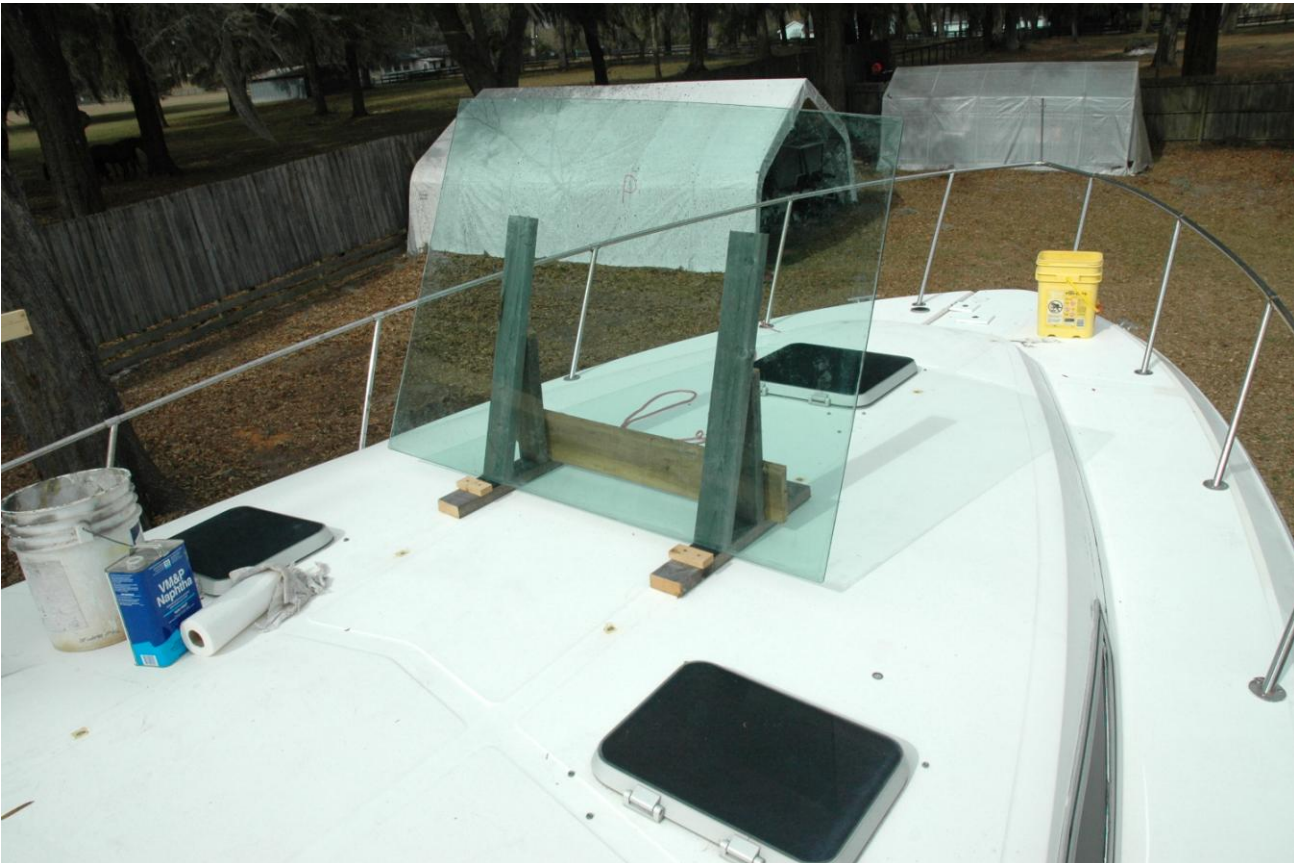
Figure 15 Glass is really big. NEVER lay flat! Always on edge!

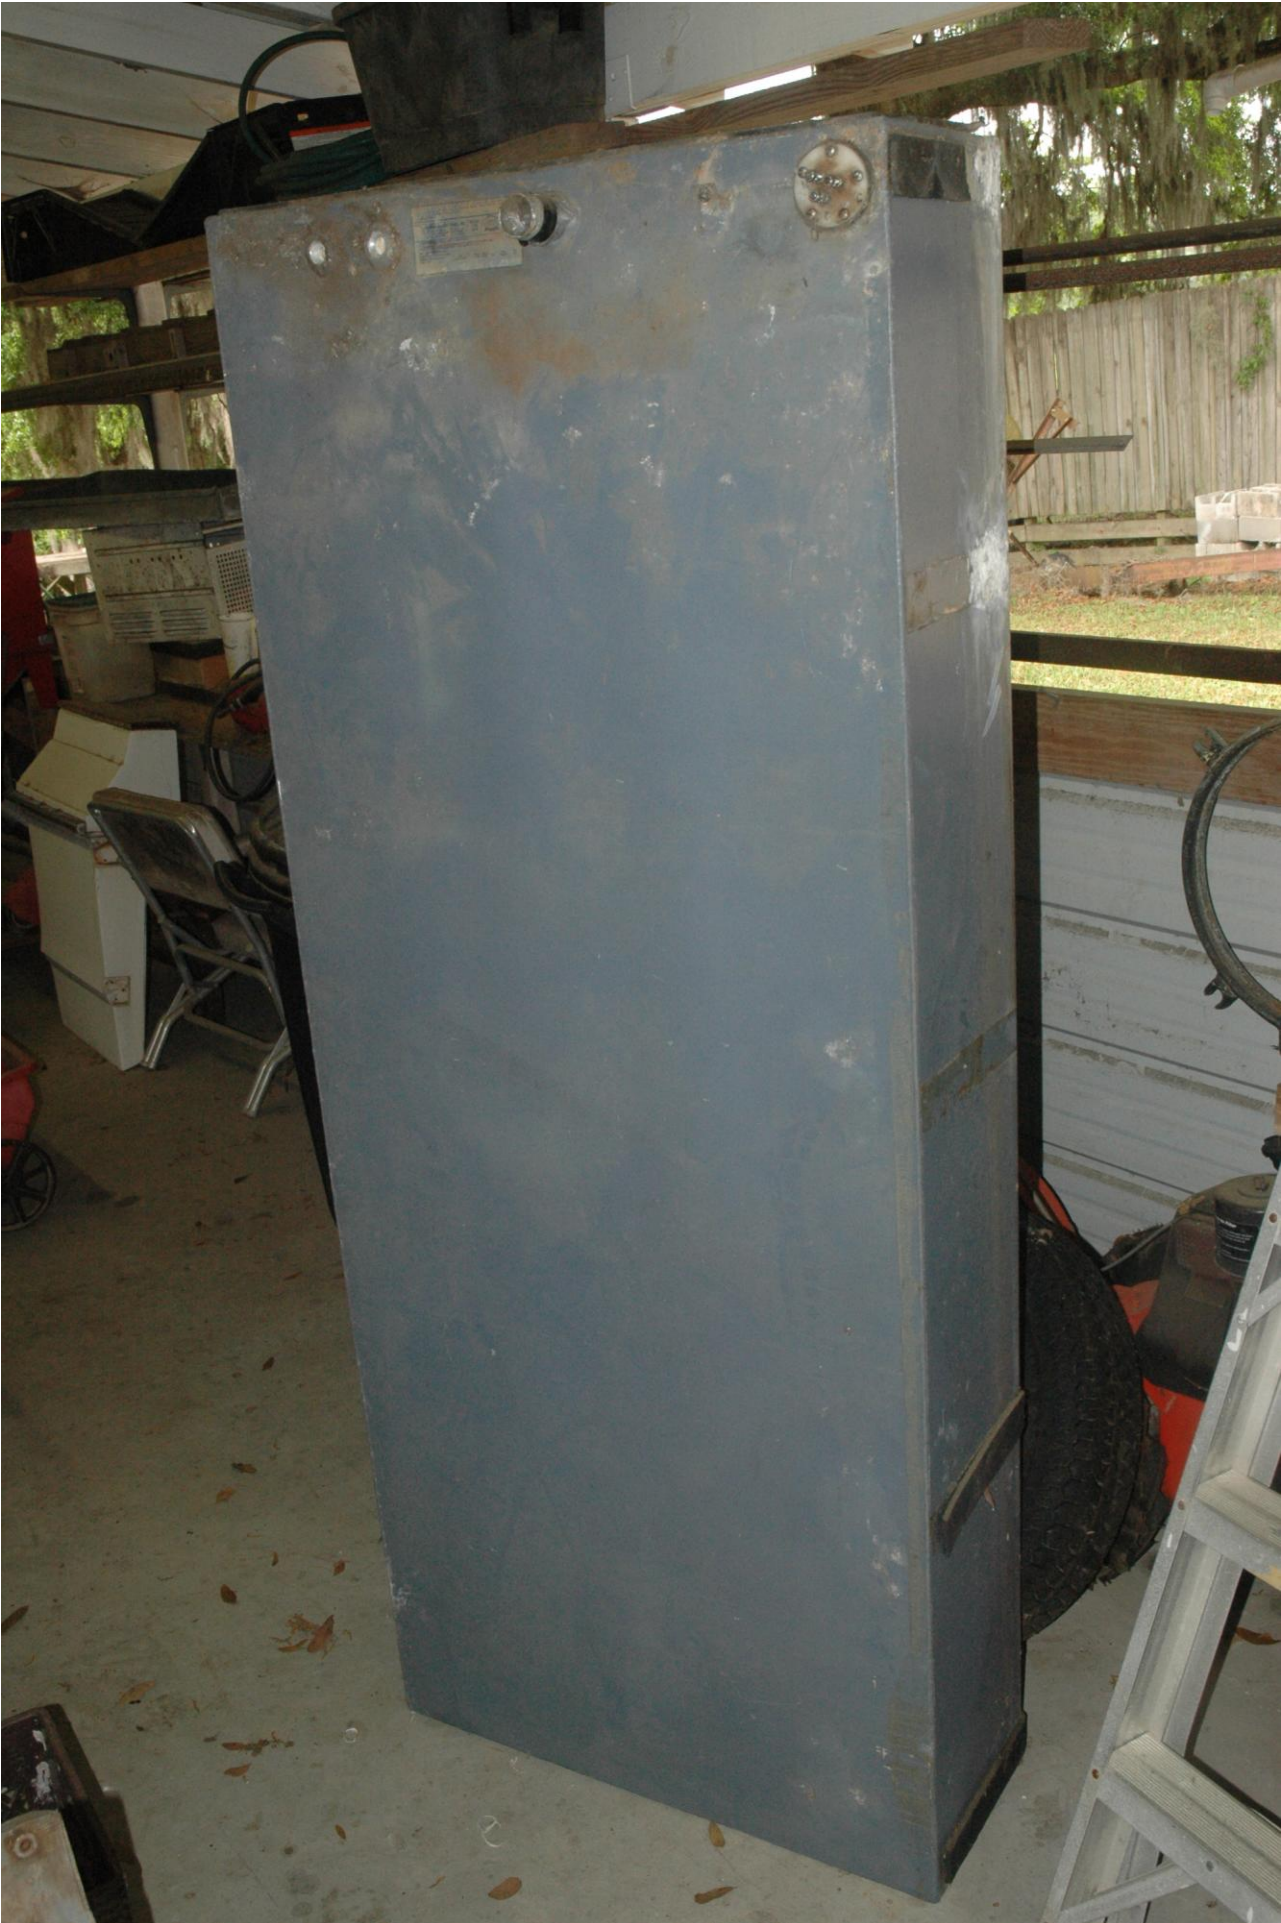
Figure 30 Sorry I don't have a photo of the swiss cheese underside of the tank. I sold it for scrap.
